Supplementary File 1.

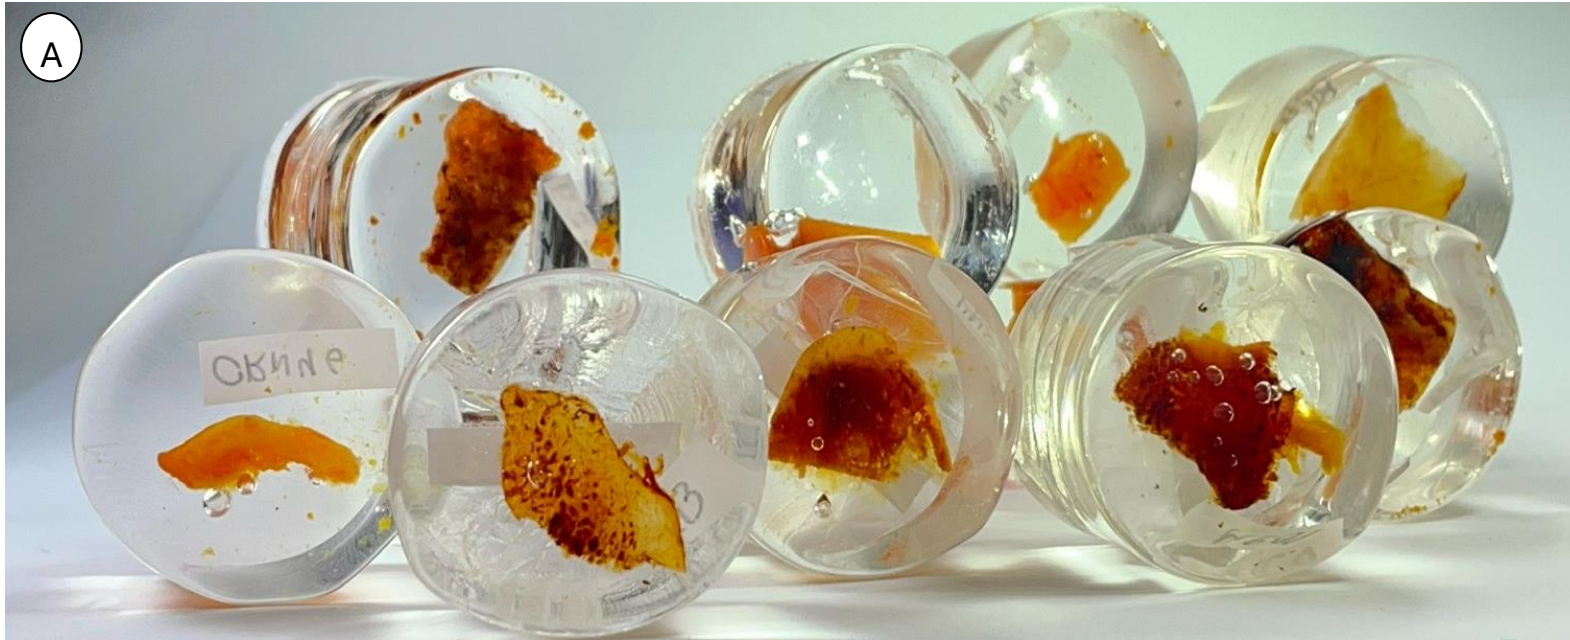
A) Bone embedded in MMA. Different blocks of MMA containing bone fragments, embedded without decalcification.

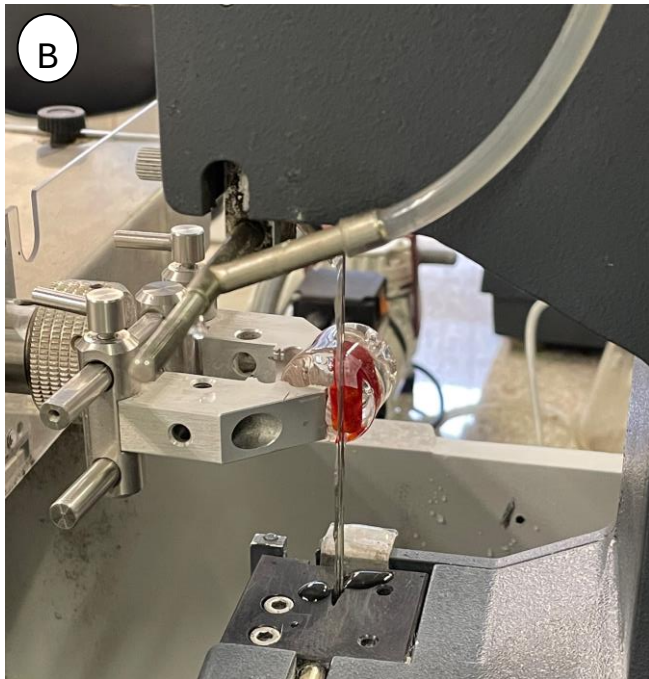
B) The block being sectioned using a precision saw.

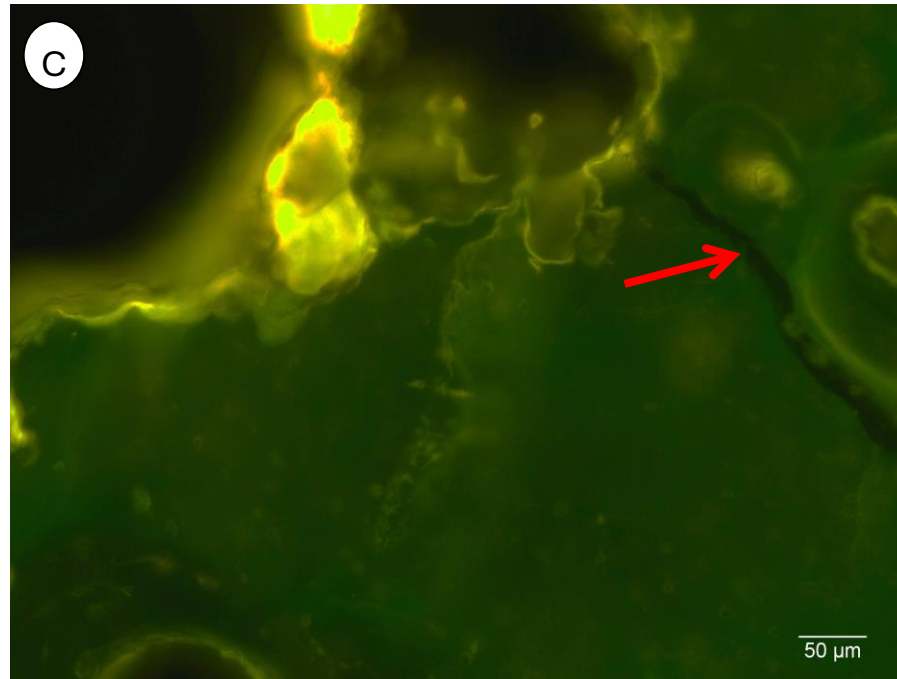
C) Histological slide analyzed under fluorescence microscopy. A cortical bone with eroded surfaces is visible, along with an artefactual microfracture (red arrow). The microfracture is identified as artefactual due to the absence of the characteristic shiny stain on the fracture surface, lacking the typical bright halo.
